TECHNICAL SERVICE BULLETIN #156.2

e*spec Shimano™ alloy crank tech update

Product(s) included: e*thirteen e*spec Shimano EP8 alloy cranks.

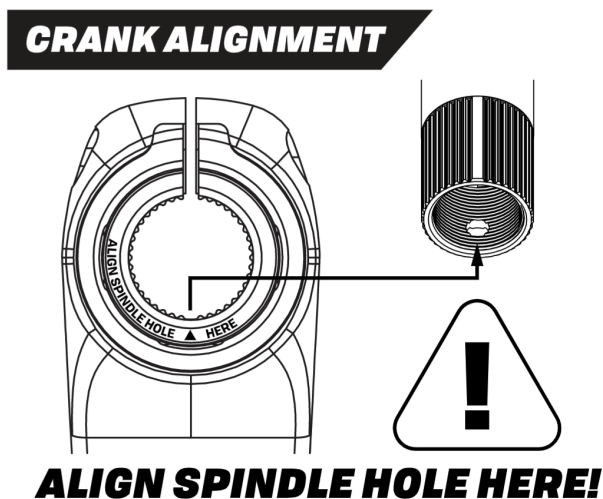
Arm Install Orientation

Verify crank arms are installed on the spindle with pinch clamp at 180 degrees from the hole in the spindle as shown in image below.
