TECHNICAL SERVICE BULLETIN #156.2

e*spec Shimano™ alloy crank tech update

Product(s) included: e*thirteen e*spec Shimano EP8 alloy cranks.

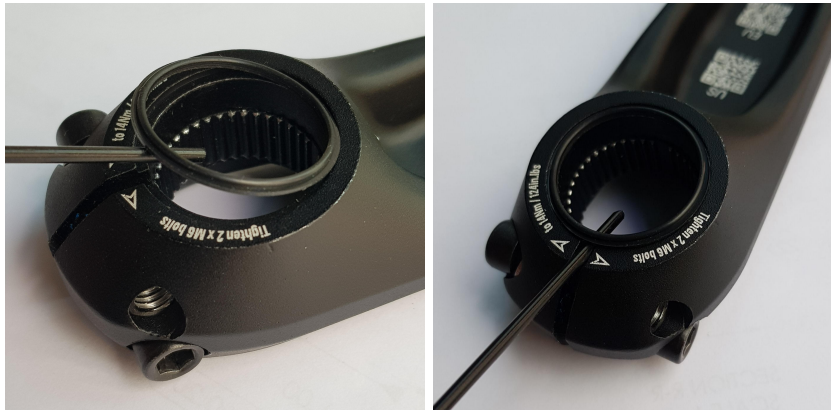
- Torque specification updates:
 - Original torque specification: Preload cap: 1Nm / Pinch bolts: 12-14Nm.*
 - Updated torque spec: Preload cap 2Nm / Pinch bolts: 14Nm.***Correct tightening procedure is critical. Please reference directions below*
- Inner seal removal:
 - The seal found at the inner face of the crank should be removed from the assembly. This avoids potential false torque readings and provides an additional 1mm of interface between the crank and spindle.
