TECHNICAL SERVICE BULLETIN #164

Provided By: e*thirteen Technical & Engineering Dept.

Helix Steel Cluster Heat Treatment Issue

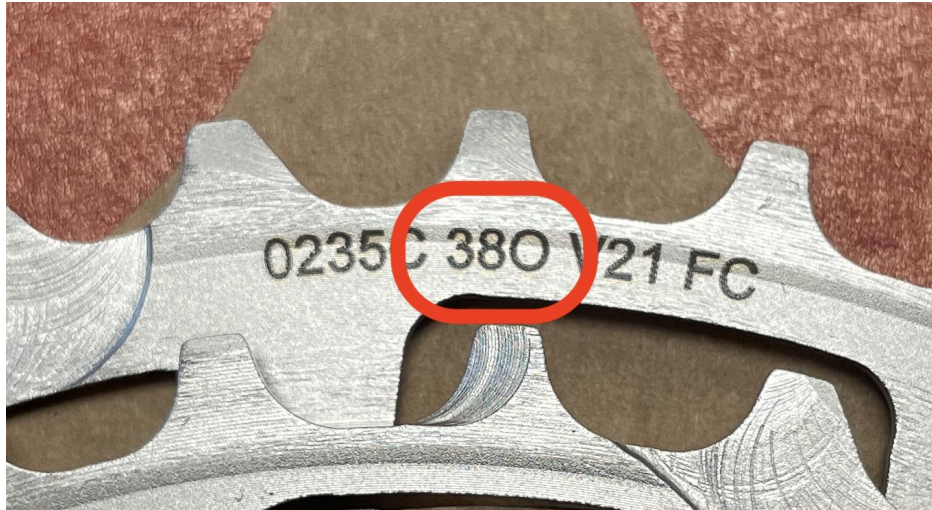
- The production date code can be found laser etched on the largest cog of the steel cassette section as shown in the image below. Date codes are in the form of 2 numbers and a letter; in the example below, 38 + 0:

- e*thirteen will replace impacted steel portions of cassettes listed according to our warranty policy.

- Only the **steel portions** of the cassettes of the noted production batches and models are impacted.
- e*thirteen is making every effort to limit the quantity of these cassettes that reach the market by working with distribution and retail partners.
- Riders with impacted cassettes should file a warranty claim via support.ethirteen.com to have their steel section replaced with a properly heat-treated part.
